Case 350 : Narrative

Case Vehicle (A): 1999 Ford	Vehicle (B): 2000 Ford	Vehicle (C): 1996 Dodge
Type: F150 regular cab, 4x2, 2-door pickup	Type: Windstar LX, 4x2 3-dr wagon	Type: Neon, 4-door sedan
Driver: 19-year-old male	Driver: 46-year-old male	Driver: 20-year-old male
CDC: 12-FDEW-2, 00-TDDO-2, 99-0000-0	CDC: 99-0000-0	CDC: 11-FDEW-4

Case No.: 350-02

Case Veh. (A): 1999 Ford

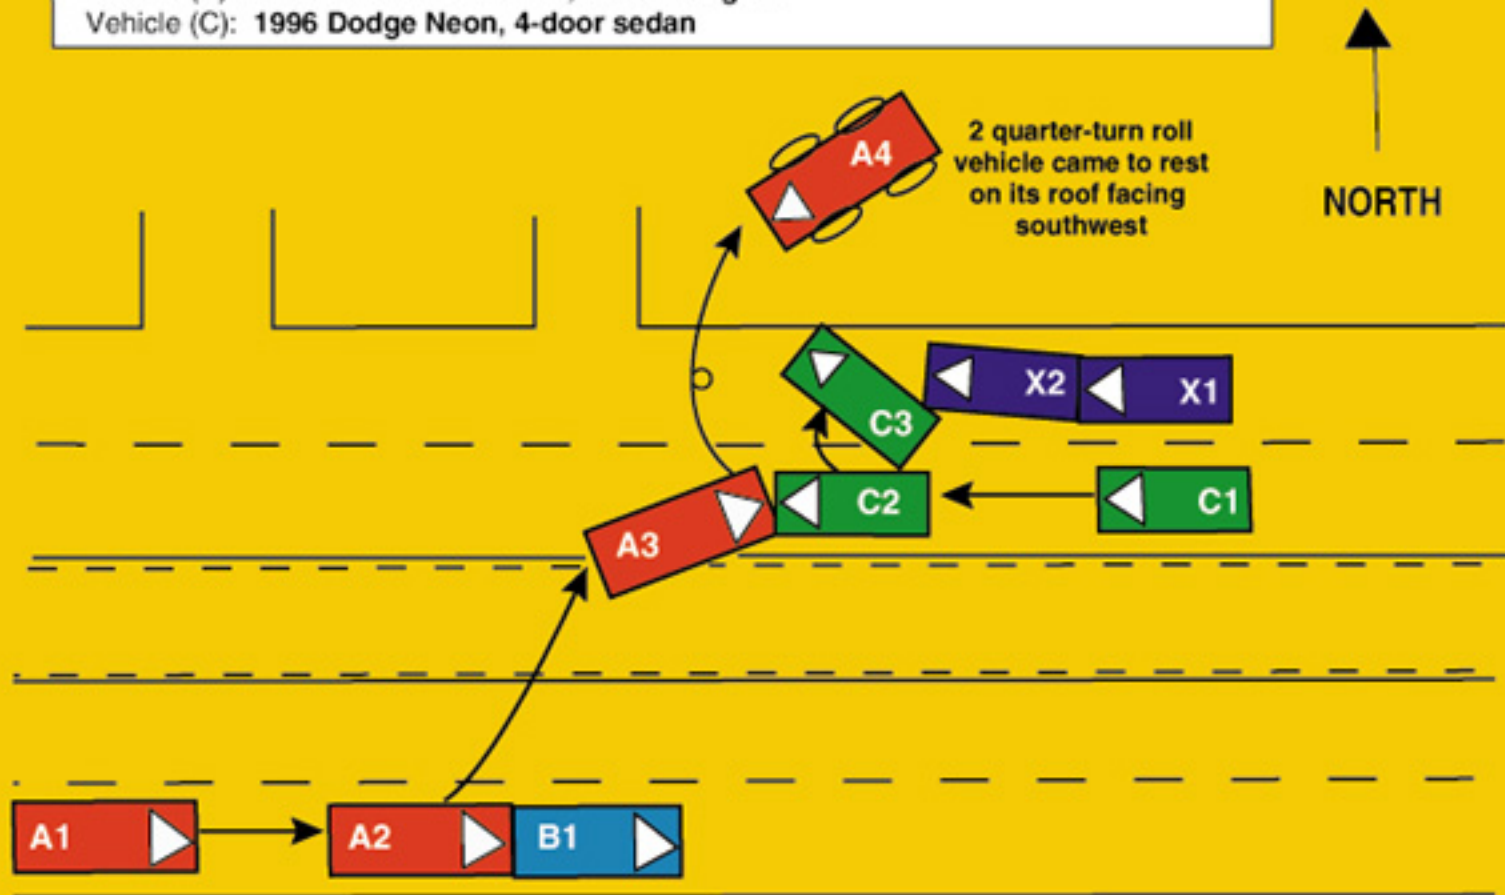
posted speed limit 45 mph (72 kph)

1 2 On a cloudy day in an urban area, case vehicle (A) was traveling east at an unknown speed in the outer eastbound lane of a five-lane asphalt road that is equipped with a center turn lane. The roads were dry, it was daylight, and the speed limit was 45 mph (72 kph). Vehicle (B) was traveling east at an unknown speed in the outer eastbound lane on the same two-lane roadway and was in front of case vehicle (A). 3 For an unknown reason the driver of case vehicle (A) lost consciousness and the front of case vehicle (A) struck the rear of vehicle (B). 4 After the impact, case vehicle (A) veered across the inner eastbound lane and center turn lane, and entered the inner westbound lane where 5 6 vehicle (C) was traveling west at an unknown speed. The driver of vehicle (C) was unable to avoid a collision and the front of vehicle (C) struck the right front of case vehicle (A). 7 After the impact, case vehicle (A) rotated clockwise, exited the north edge of the road, and began sliding to the left. 8 The left-rear wheels dug into the dirt and the vehicle rolled two quarter turns with the left side leading, and came to rest on its roof facing southwest. After the impact, vehicle (C) rotated clockwise into the outer westbound lane where it was impacted in the right rear by vehicle (X). Case vehicle (A) and vehicle (C) were towed from the scene, while vehicle (B) was driven from the scene.
